Manhole Inspection Summary

Manhole # S17EE1064MH

Record Plat: **17EE1** Node: **064** Status: **New Manhole (Not in GIS)** Insp Date: **3/22/07 12:00 AM**

Location Address: **3801 GREENSPRING AVE** Cross Street: **KEYWORTH AVE**

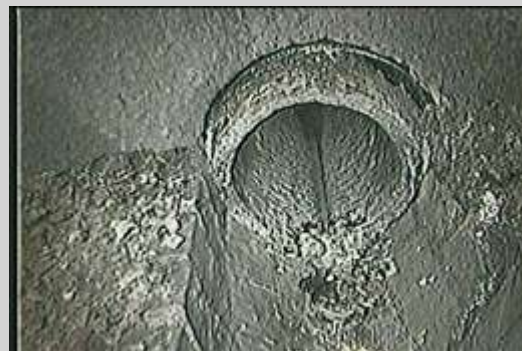
Drop In @ 4 O'Clock

Infiltration: **Evidence** Pipe Seal Cond: **Unknown**

Drop: **Outside** Rod and Bar

Drop Condition: **Open**

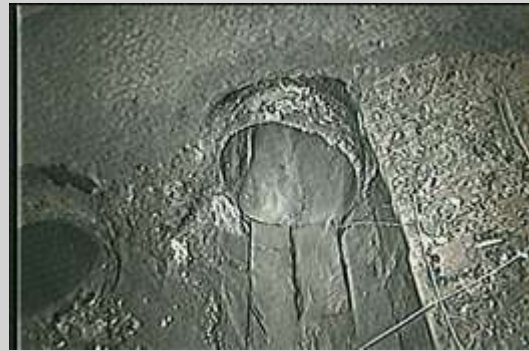
Drop In @ 6 O'Clock

Infiltration: **Evidence** Pipe Seal Cond: **Unknown**

Drop Condition: **Open**
